# Manhole Inspection Summary

Manhole # S19A\_\_023MH

Insp Date: **9/21/09 10:29 AM**

**Location** Address: **807 LANVALE ST**

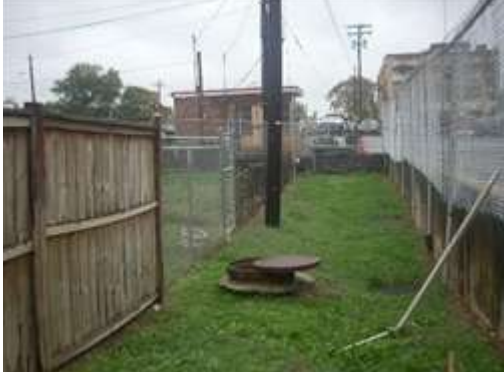
Location View

GRADE ADJUSTMENT

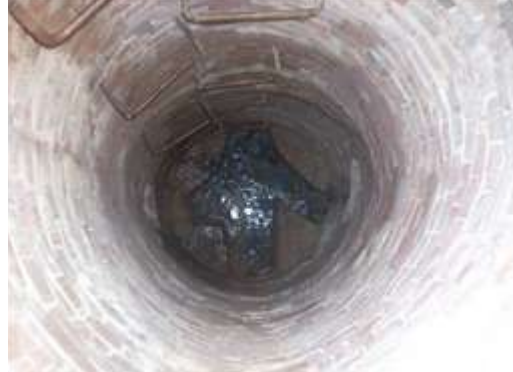
Top View

ABANDONED PIPE AT I9

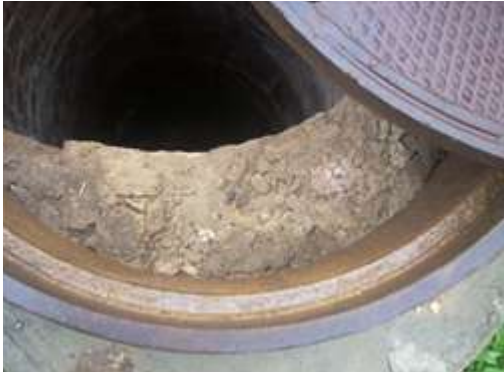
Defect 1

Offset: **8** (in.)

FRAME OFFSET

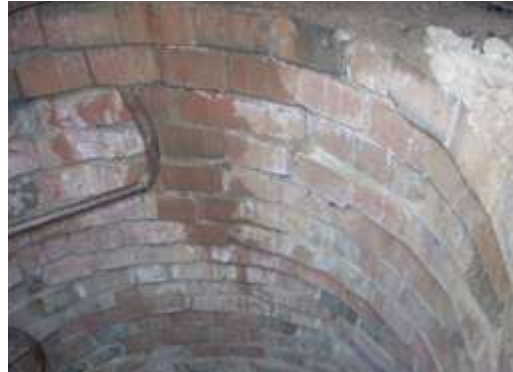
Defect 4

INFILTRATION OF CORBEL JOINT

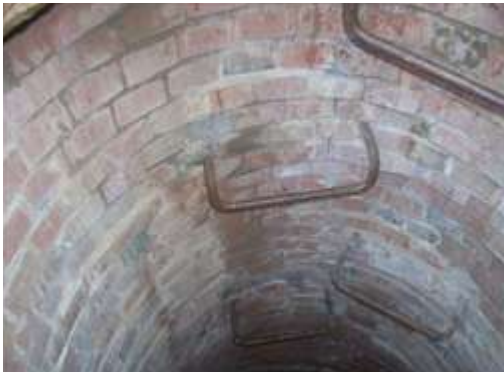
Defect 3

INFILTRATION OF DETERIORATED CORBEL WALL

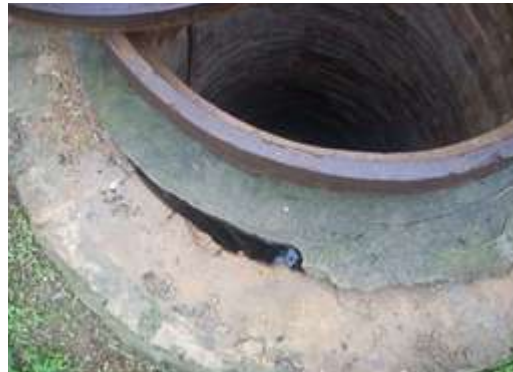
Defect 2

Comments **there is a hole between frame and chimney**

HOLE BETWEEN FRAME AND CHIMNEY

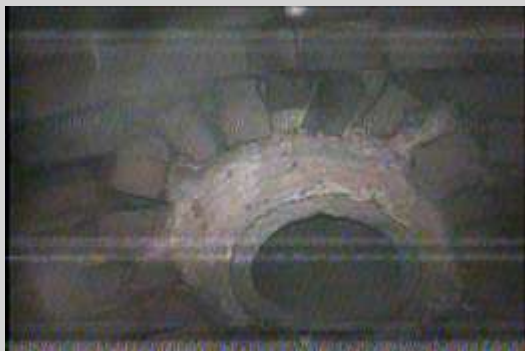
3 O'Clock Inflow

Pipe Height: **8.4** (in.) Rod and Bar (Angled)  
Pipe Material: **Clay** ☐ Pipe Lined  
Invert Depth: **11.87** (ft.) Flow Characteristics: **Slow**  
Deposits: ☐ None ☐ Mud ☐ Sludge ☒ **Debris** ☐ Grease  
Silt Depth: **1** (in.) Deposits Extent: **Light**  
Infiltration: **None** Pipe Seal Cond: **Sound**

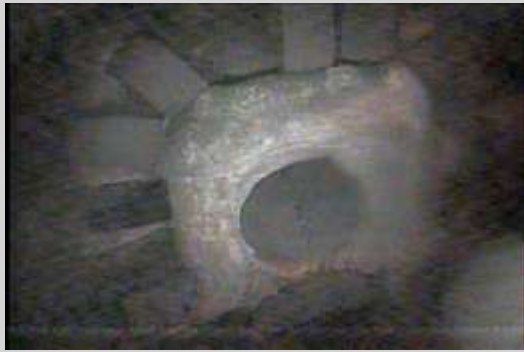
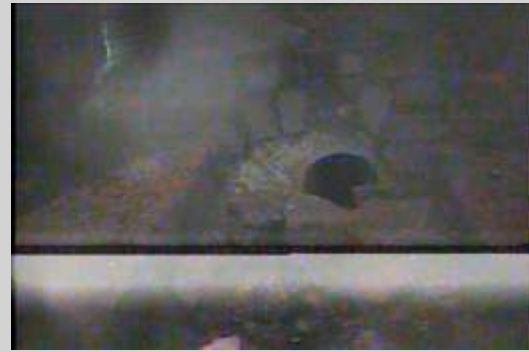
6 O'Clock Inflow

Deposits: ☐ None ☐ Mud ☐ Sludge ☒ **Debris** ☐ Grease

Silt Depth: **2** (in.) Deposits Extent: **Medium**
